KOENIGS CREEK DAM

NDI NO. PA-00668

PHASE I INSPECTION REPORT  
NATIONAL DAM INSPECTION PROGRAM

Name of Dam: KOENIGS CREEK DAM  
State & State No: PENNSYLVANIA, 54-169  
County: SCHUYLKILL  
Stream: KOENIGS CREEK  
Date of Inspection: May 8, 1979

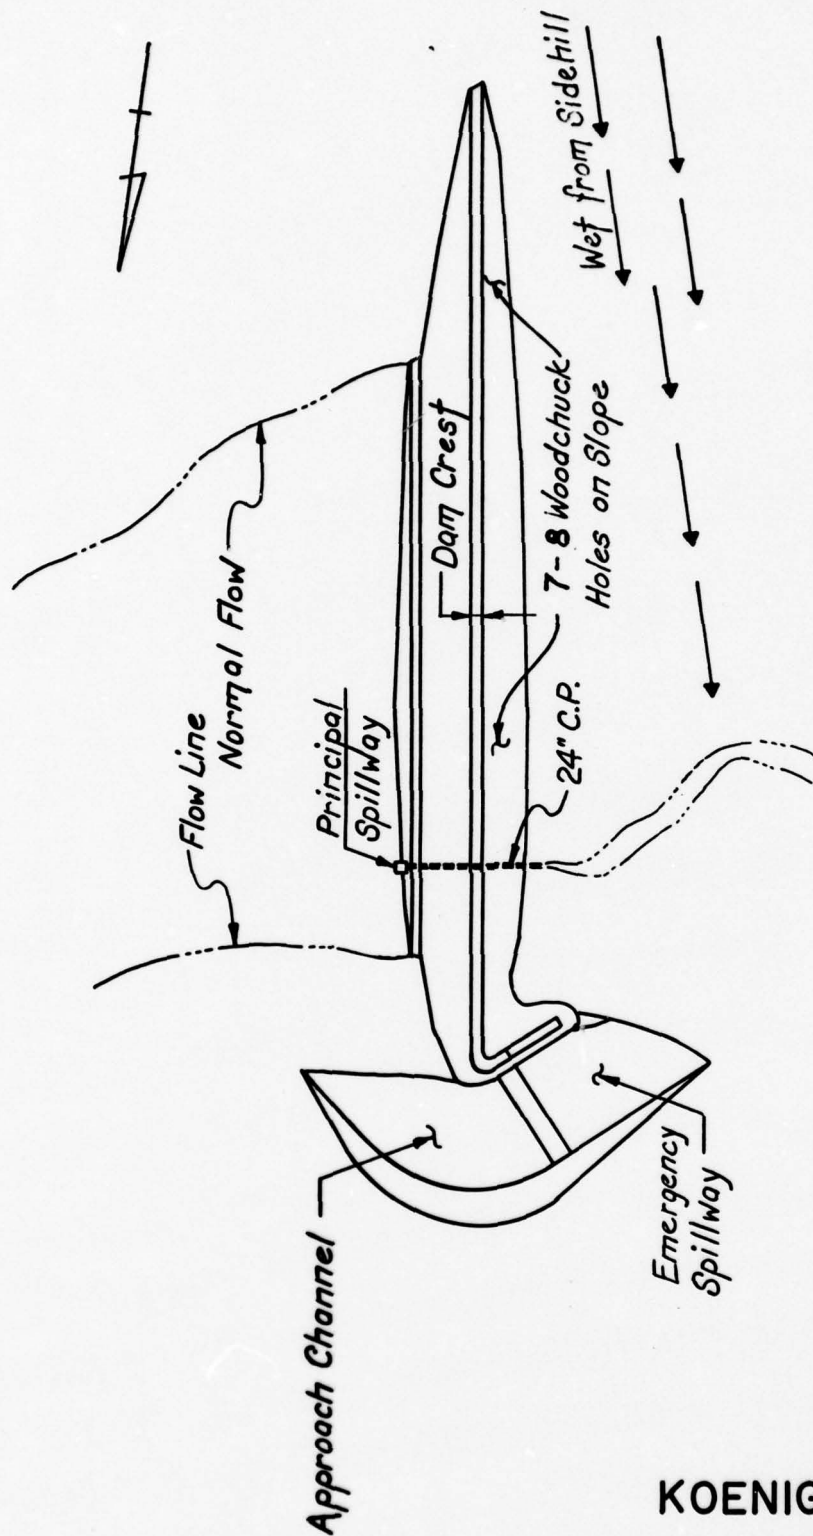
PLATE A-I

A surveyed profile along the crest of the dam shows a variation of 0.1 to 0.6 foot below the design elevation. The 0.6 foot occurs at only one point near the left abutment. The average deviation would be about -0.1 foot. The upstream and downstream slopes were found to be essentially as designed. Refer to Appendix A, Plates II and III for survey information and Appendix E for photographs of existing facilities.

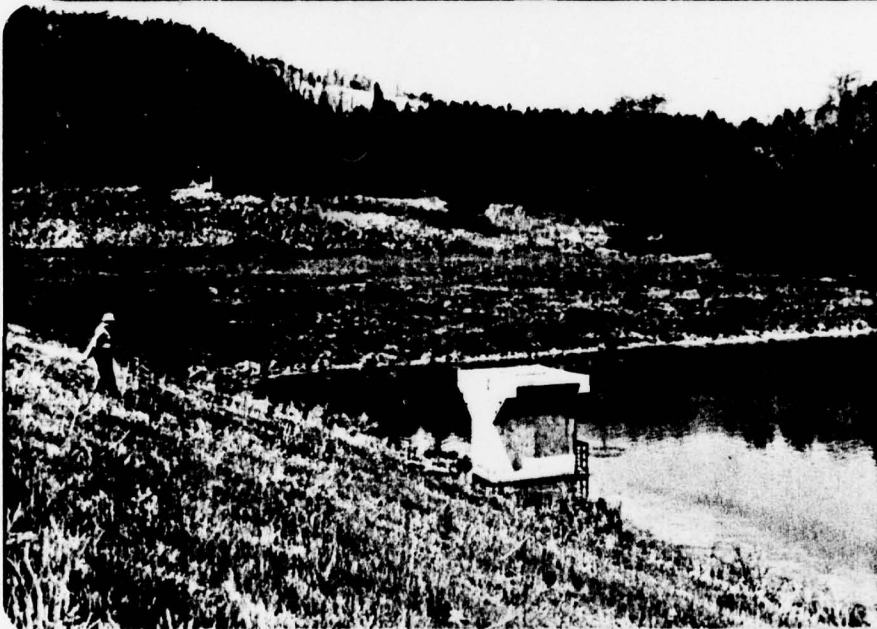
Intake Structure

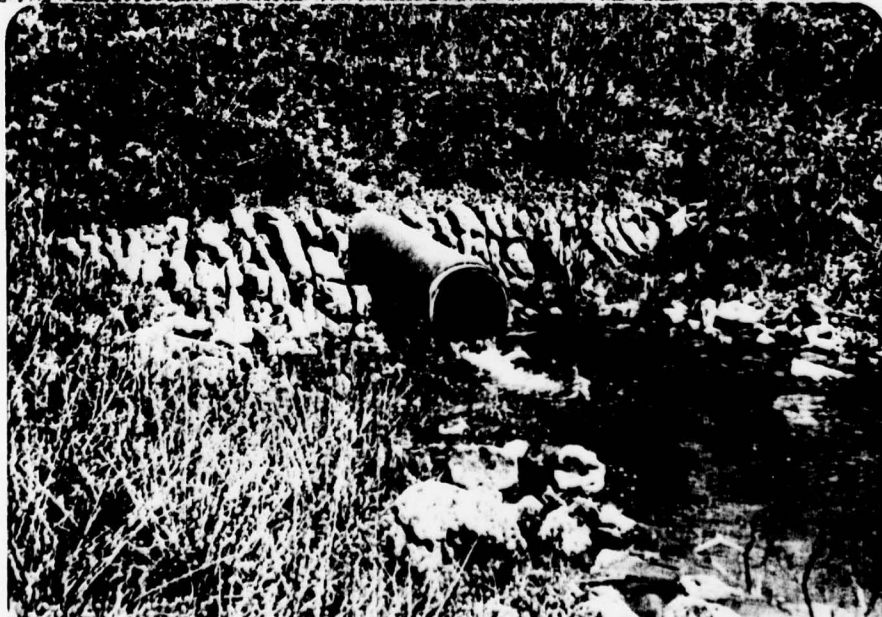
Outlet Pipe

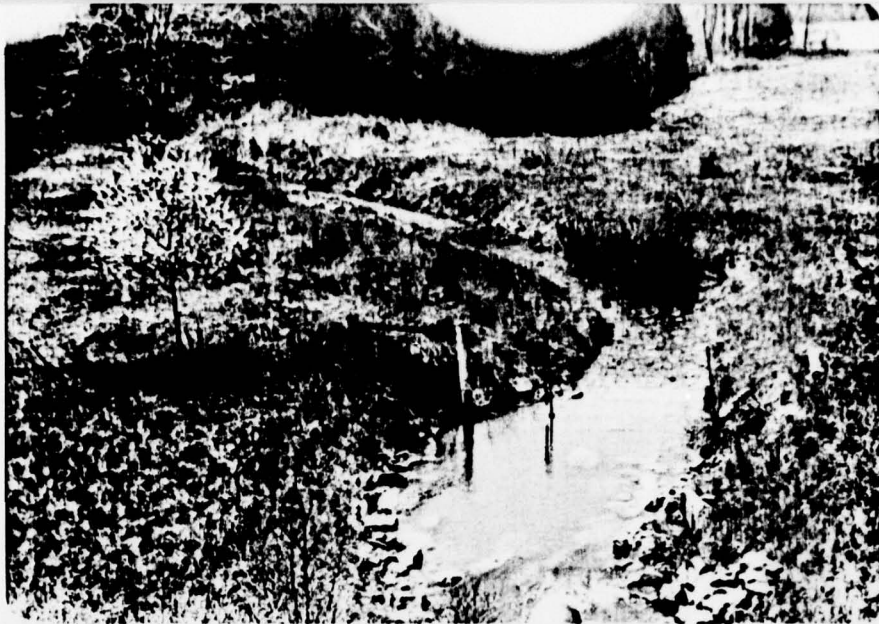
Downstream Channel  
Outlet Pipe

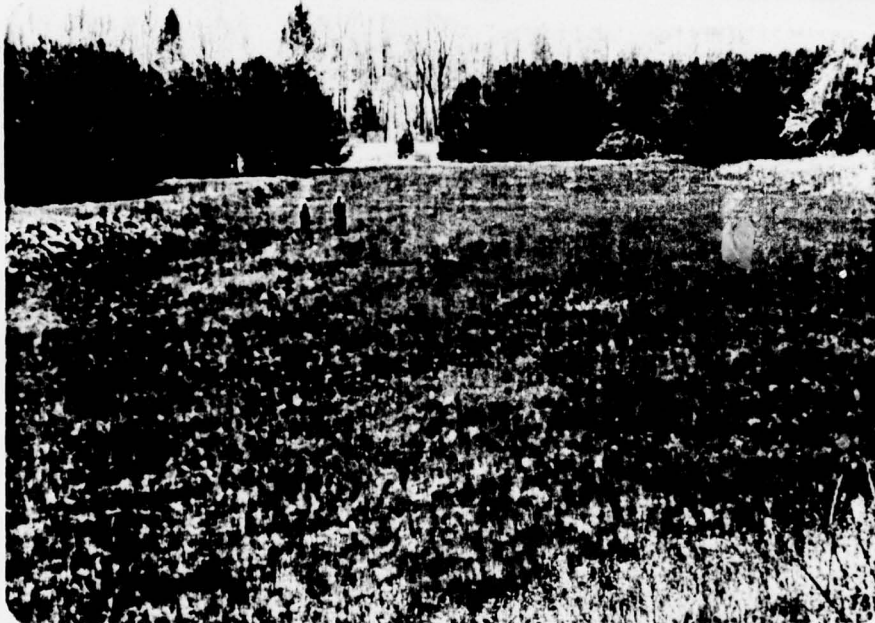
The emergency spillway is covered with a firm stand of grass. It is in very good condition and it appears that erosion will not be a problem in the event of flood flow through this area.

Emergency Spillway  
Looking  
Downstream
